BULLETIN No. 1107

THE LEAD-CABLE BORER OR "SHORT-CIRCUIT BEETLE" IN CALIFORNIA.¹

By H. E. Burke, Entomologist, R. D. Hartman, Field Superintendent in Insect Control, and T. E. Snyder, Entomologist, Forest Insect Investigations, Bureau of Entomology.

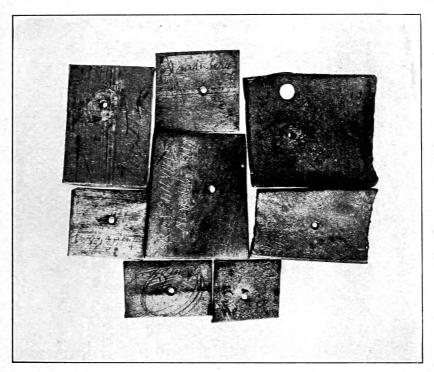
Damage to the lead sheathing of aerial telephone cables consists of perfectly round holes about 2.5 millimeters (0.1 inch) in diameter which extend through the lead sheathing from the outer surface to the paper insulation of the wires within. (Pl. VI, Fig. 3; Text Fig. 3.) Cables of various diameters are attacked. In practically every case the hole is made through the lower side of the sheath close to where the suspending ring or metal or marline hanger supports the cable. In a few cases the damage is done where the cable has been scarred or roughened or where an upright cable has been fastened to the poles by clamps. In a number of cases where attempts had been made on the sheathing the work was abandoned before the sheathing was penetrated. In cases where the sheathing is penetrated, moisture is very readily drawn in to the wires and the entire supply of electric current may be short-circuited. If the hole happens to be in the proper location a great deal of moisture enters and the cable may be ruined for 15 to 20 feet. Particularly in case of slack cable or those on grades the moisture sometimes penetrates and soaks the insulation for long distances. This necessitates cutting out the cable, splicing and insulating the wires, and resheathing, which in a 600-pair cable means considerable skilled labor.

Most of the damage is probably done from June to August, when the beetles are emerging in large numbers. The injury is not apparent, however, until later, after the rains, when the water soaks through and causes a short circuit. Thus usually all the "troubles" come at once.

Fig. 3.—Holes bored in the lead sheathing of aerial cables by the California lead-cable borer (Scobicia declivis) at various localities in California. Natural size.

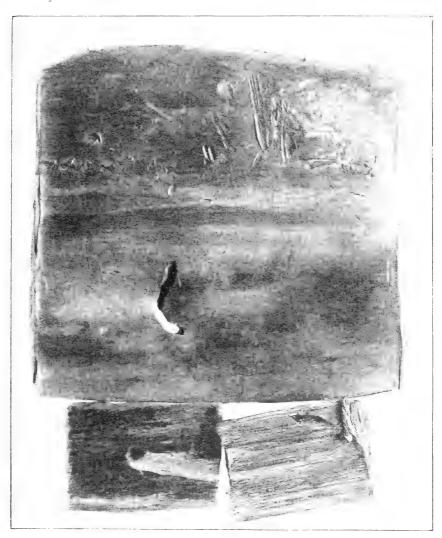
Fig. 6.—Hole accidentally bored through lead sheathing of a cable on a telephone pole by a wood-boring beetle in its efforts to emerge from the wood of the pole. Natural size.

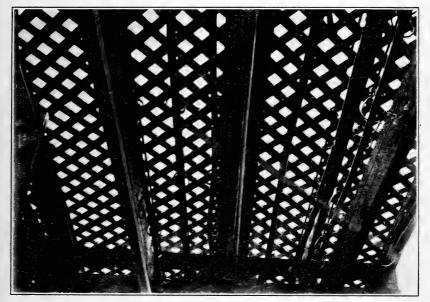
Fig. 15.—Interior of experimental cage at Falls Church, Va., showing lead-sheathed cables of different alloy composition suspended on different types of rings from beams of roof.

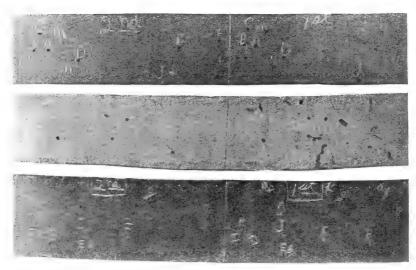
Fig. 3.—First two thicknesses of the three treated lead sheathings after being removed from infested section and manner in which beetles stopped as successive thicknesses were reached. Upper, embedded carborundum, where 17 beetles started in first thickness and 14 reached the second. Middle, tin-coated section, where 14 started in the first and 6 reached the second thickness. Lower, copper-coated section, with 16 and 12 penetrations, respectively. One-fifth natural size. (Table 2, Nos. 54, 54c, 54b.) Photograph by R. D. Hartman.
